Confidential Inspection Report

LOCATED AT:
902 Cumberland Street
Clearfield, Pennsylvania 16830

INSPECTED ON:
Monday, February 22, 2021

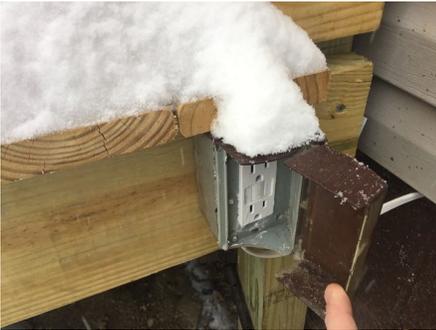
The receptacle is not working. We recommend further investigation and repair, if necessary.

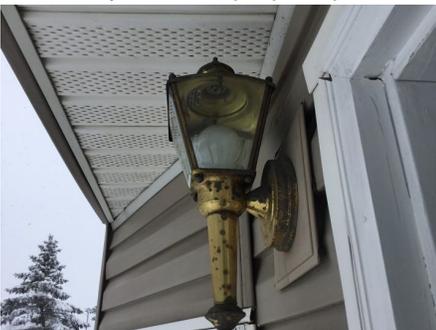
OUTDOOR LIGHTS

The light fixtures are not working. The bulbs may have burned out. We recommend that the bulbs be replaced, if necessary, and the proper operation of the fixtures be verified.

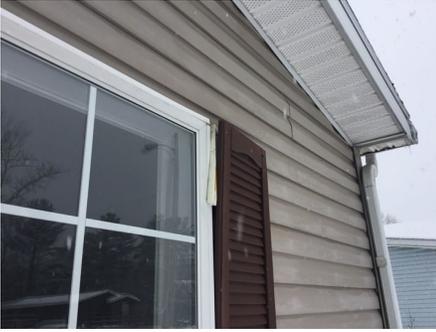
The shutter is loose. We recommend it be repaired.

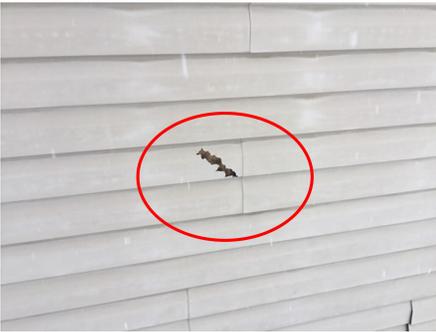
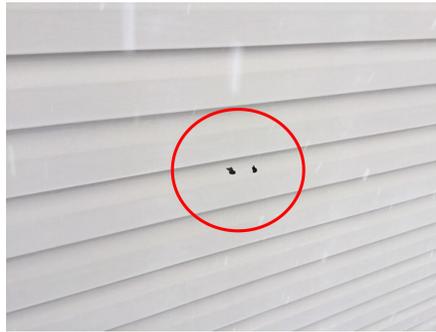
Sections of the vinyl siding are punctured. We recommend these sections be repaired / sealed to prevent water entry.

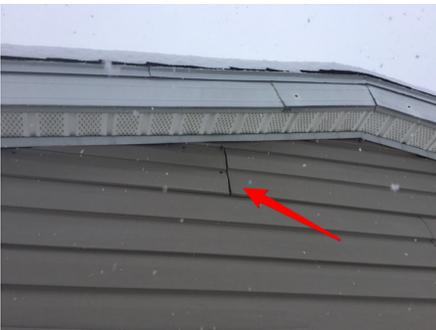
Sections of the vinyl siding are inadequately secured to the exterior wall. We recommend that the vinyl siding be resecured properly.

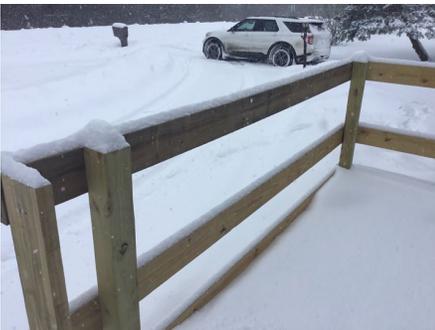
RAILINGS

The railing pickets at the front deck spacing is greater than 4 inches. We recommend they be repaired in accordance with current standards.

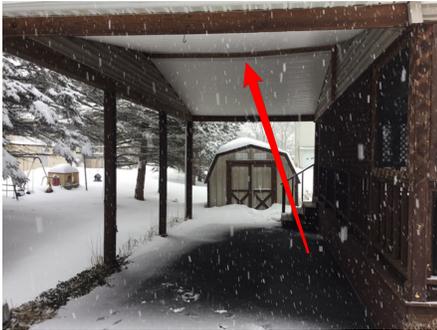
The roof is sagging in the carport. We recommend this condition be monitored for evidence of further sagging. It is possible that the original installation has reached an equilibrium and no action will be needed.

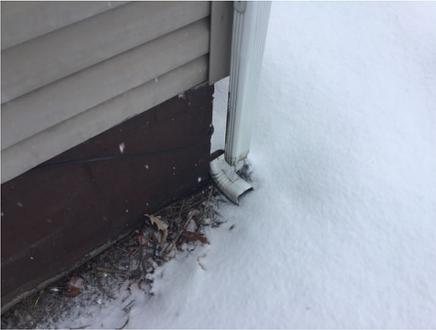
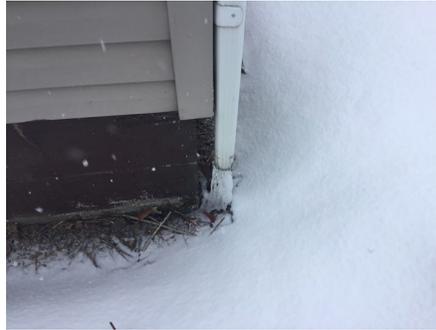
Runoff water from the roof discharges next to the house. We recommend the downspouts be routed sufficiently away from the structure to prevent puddling, pooling, and saturation of the soil around the building.

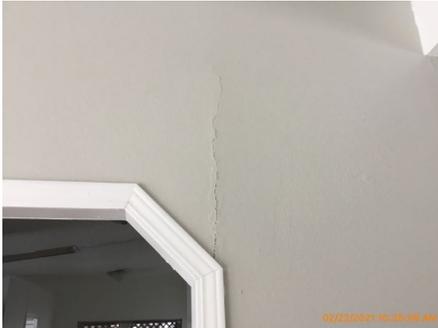
There are minor wall cracks. This type of cracking in this material is common and does not indicate a structural deficiency. These can be patched, prepared and finished in the course of routine maintenance.

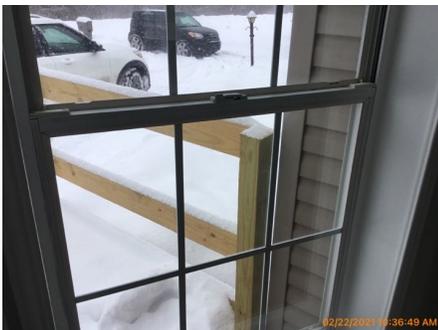
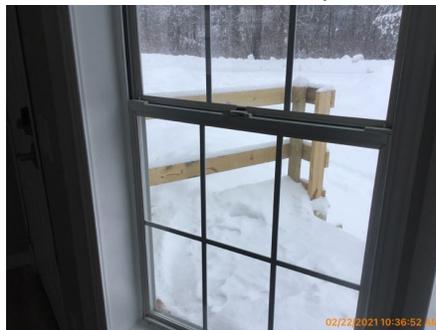
WINDOWS

The windows are stuck or have been painted shut and cannot be opened.

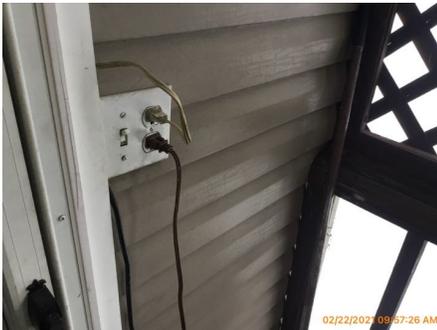
We found exposed wiring in this room. Even if insulated, we recommend all wiring be encased in a conduit or otherwise protected in accordance with present standards.

We found lamp cord/extension cord wiring in use. This type of wiring is easy to overload and can be easily damaged. Removal of all lamp cord/extension cord wiring and replacement with proper circuitry is recommended.

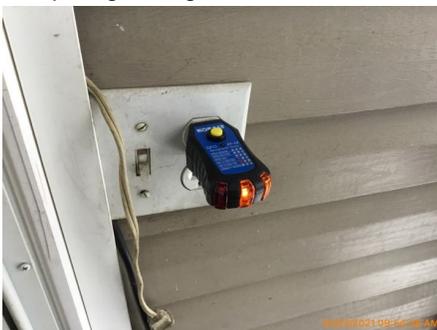
There is an ungrounded three prong receptacle. We recommend it be properly grounded or restored to its original two prong configuration.

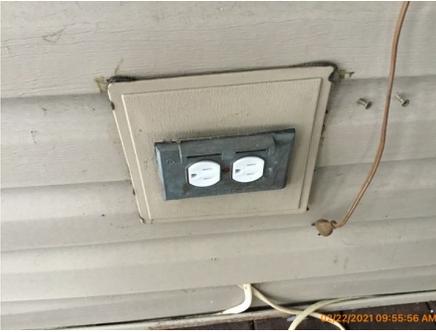
The receptacle cover plate is damaged. We recommend it be replaced during the course of normal maintenance.

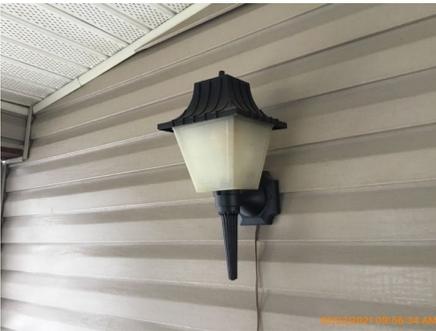
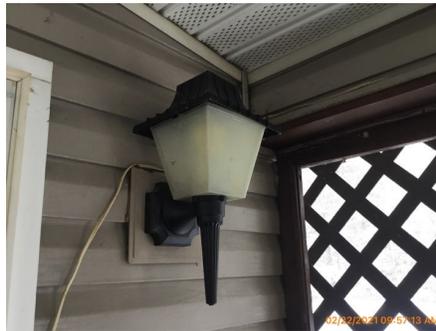
LIGHTS

Several light fixtures are not working. The bulbs may have burned out. We recommend that the bulbs be tested and replaced, if necessary, and the proper operation of the fixtures be verified.

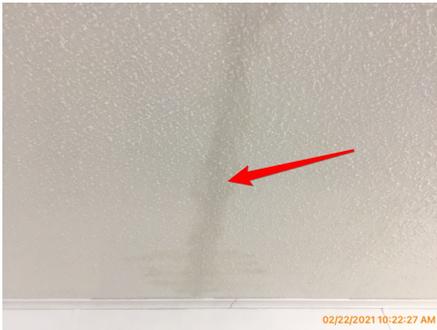
CEILING

There are minor ceiling cracks. This type of cracking in this material is common and does not indicate a structural deficiency. These can be patched, prepared and finished in the course of routine maintenance.

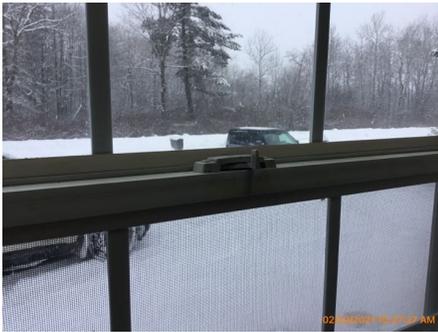
WINDOWS

One window doesn't close tightly and is difficult to latch. All windows should be detailed, including scraping excess paint build-up, cleaning, lubricating, and adjusting hardware where necessary.

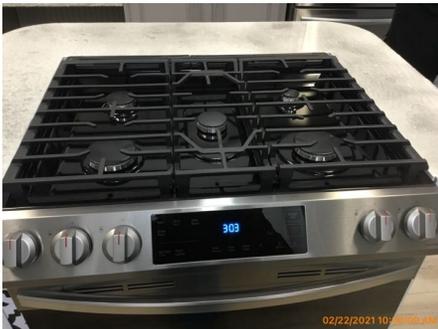
STOVE

The stove was not fully functional at time of inspection.

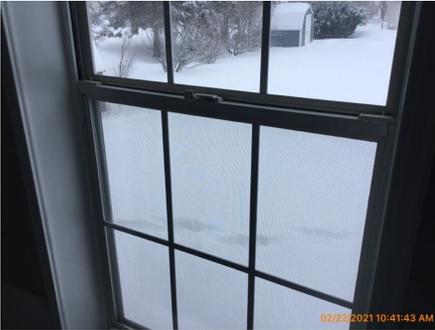
The window is stuck and cannot be opened. We recommend repair to restore functional use.

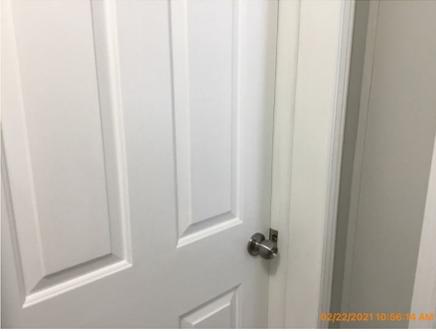
The door rubs on the frame. We recommend it be planed or sanded for smoother operation.

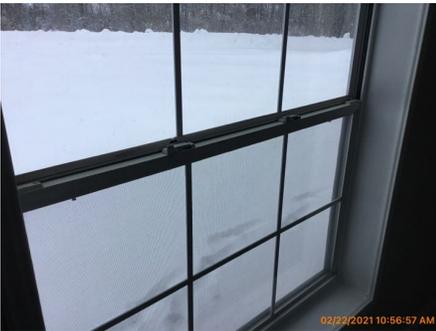
WINDOWS

The window is stuck and cannot be opened. We recommend repair to restore functional use.

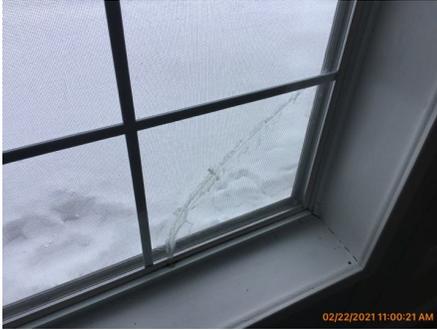
The panes of glass are broken. We recommend all broken glass be replaced.

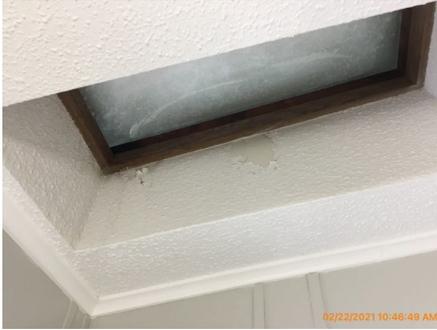
The ceiling surface is blemished, and can be repaired in the course of routine maintenance.

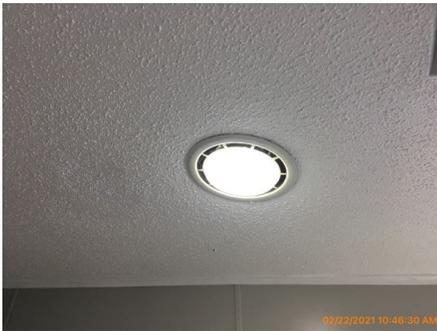
VENTILATION

The exhaust fan is very noisy. We recommend that it be serviced or replaced to restore quiet operation.

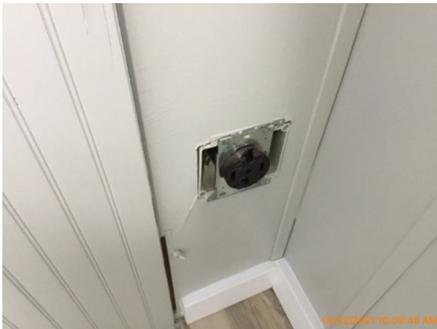
There is no GFCI (ground fault circuit interrupter) protection for this area. For an increased margin of safety, we recommend the installation of a GFCI receptacle.

The receptacle is missing its cover plate. We recommend it be replaced to reduce the risk of electrical shorts and hazardous shocks.

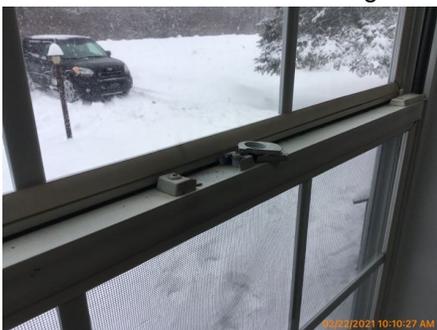
WINDOWS

The window hardware is damaged and the window is stuck shut. We recommend it be repaired or replaced.

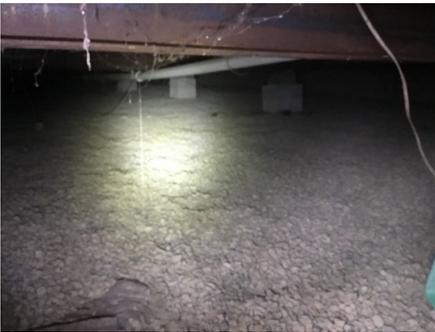
There is no vapor barrier in place in this crawl space. There is exposed insulation that will collect moisture and deteriorate. A vapor barrier is considered a beneficial feature and we recommend one be installed to prevent a moisture problem.

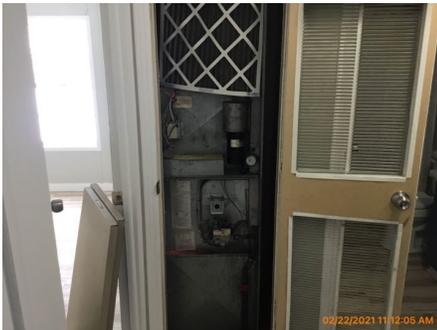
The heating system failed to respond to normal operating controls. Seller disclosed that a new heating unit is to be installed.

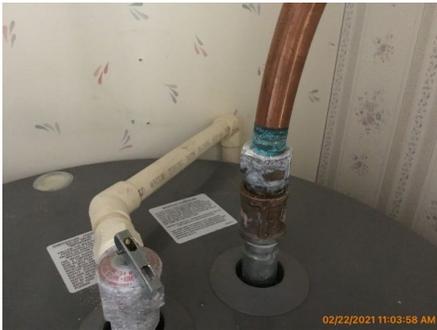
The water connections are corroded and leakage may become apparent over time. These connections should be monitored for leakage and repaired or replaced if necessary.

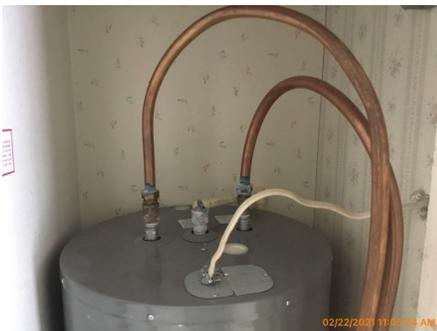
No cold water inlet valve to regulate water flow into the water heater was visible. We recommend installation of an approved valve.

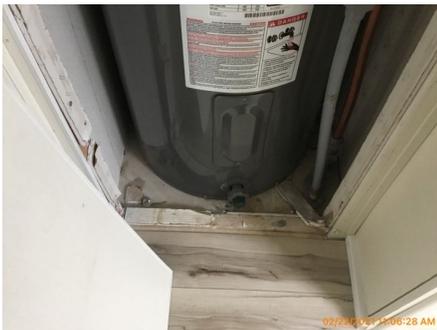
ELEVATION/LOCATION

There is no metal pan under the water heater to catch and divert any dripping water to the exterior. This is required by some jurisdictions for water heaters in this location. We suggest installation of such a pan be considered.

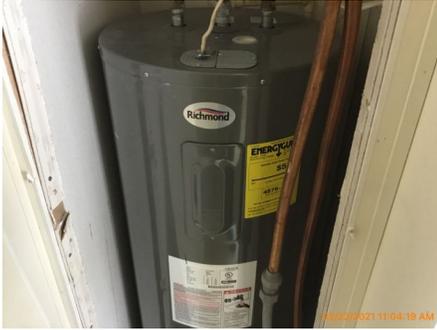
The water heater's energy source was shut off and was not operational. We cannot offer opinions about its performance. Breaker was turned off. We recommend checking with seller as to why power was turned off to this appliance.

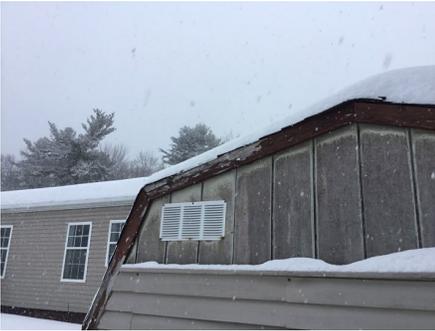
We recommend that the peeling paint on the trim be painted to prevent premature wear, moisture entry and deterioration.

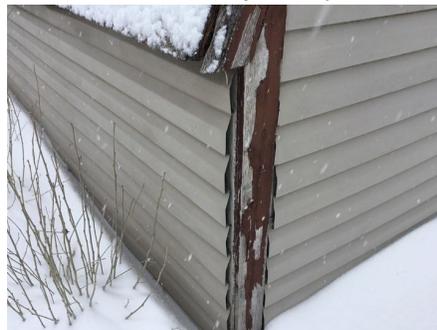
Sections of the vinyl siding are missing. We recommend they be repaired.
