## Confidential Inspection Report

LOCATED AT:  
407 Legion Ave  
Johnsonburg, Pennsylvania 15845

INSPECTED ON:  
Thursday, February 11, 2021

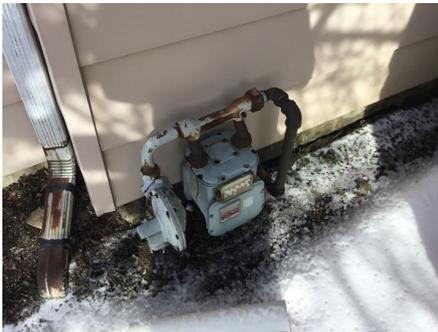
### GAS METER LOCATION

The gas meter is outside on the right side of the building. The main gas supply shutoff valve is located on the riser pipe between the ground and the meter. This valve should be turned 90 degrees (either way) in order to shut off the gas.

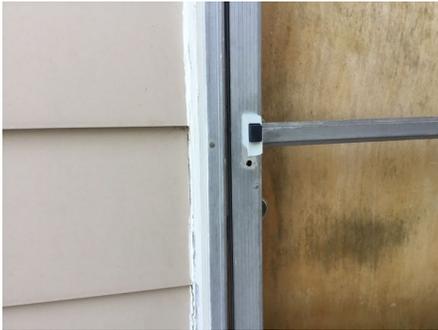
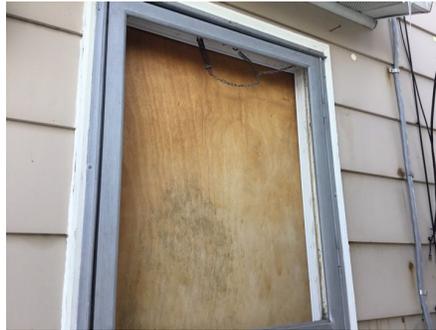
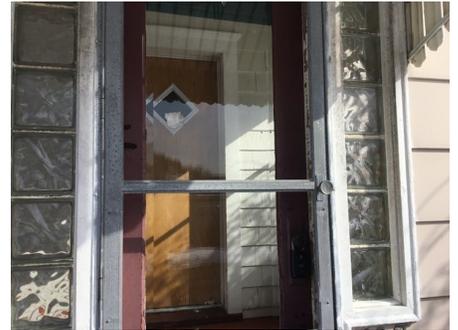
### DOORS

Several exterior doors are damaged. We recommend they be replaced.

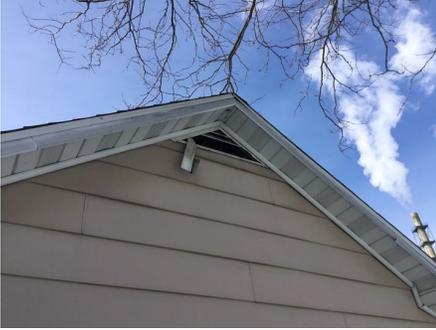
The attic eave vent is damaged. We recommend repair or replacement.

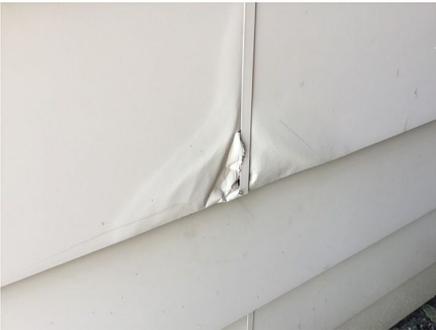
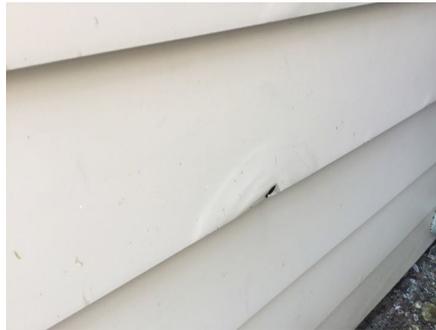
## WOOD

Sections of the siding are deteriorated. We recommend these sections be repaired or replaced.

It should be stated that wood siding and trim do have a finite service life. Maintenance and an occasional treatment or painting with a wood preservative will be most effective in prolonging service life.

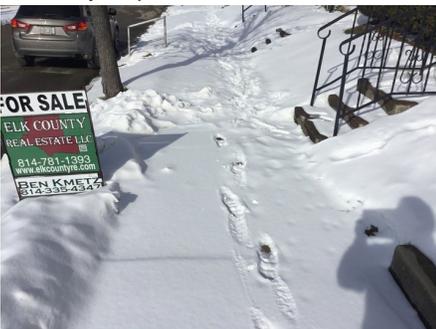
The snow cover on the walkway at the time of this inspection rendered a complete physical inspection of the walkway impractical.

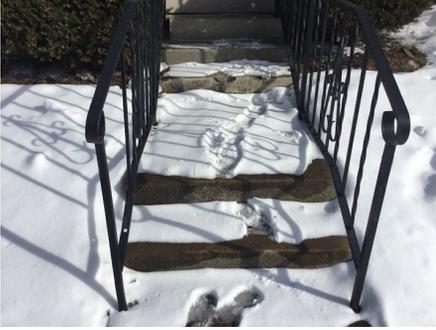
The exterior stairs appear to be properly constructed and are in serviceable condition.

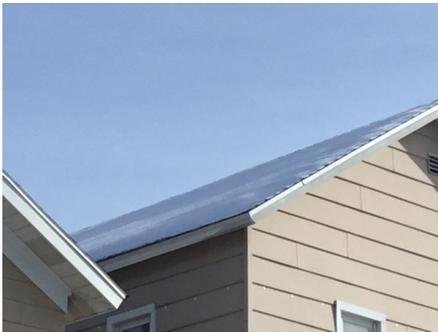
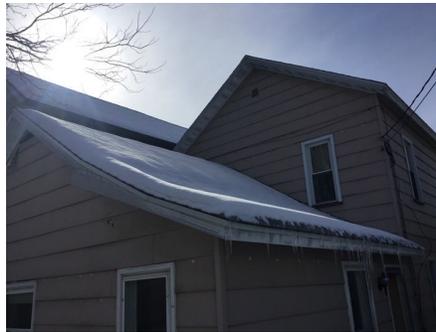
The snow cover on the roof at the time of this inspection rendered a complete physical inspection of the roof impractical. Our comments, therefore, are based upon limited visual observations.

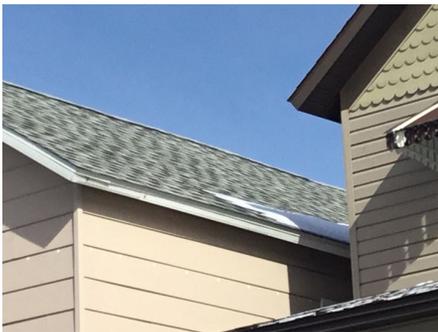
#### SURFACE

The visible shingle surface appears to have been properly installed and is in good condition.

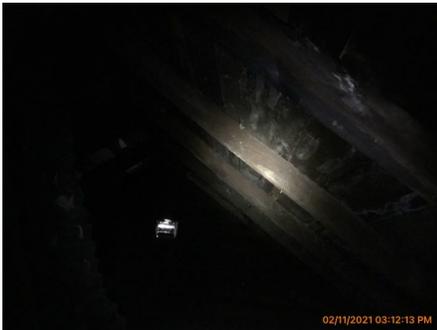
The visible roof structure appears to be constructed in a manner typical of houses of this type and age. The rafters are generally in good condition, where seen, and have performed adequately since their installation.

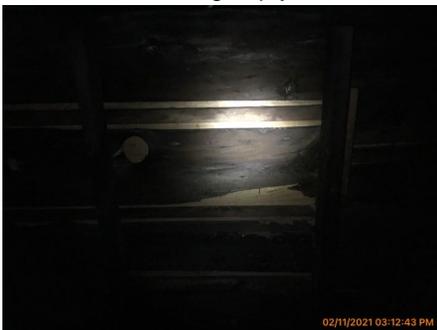
The roof sheathing is plywood nailed over a previously installed layer of board sheathing.

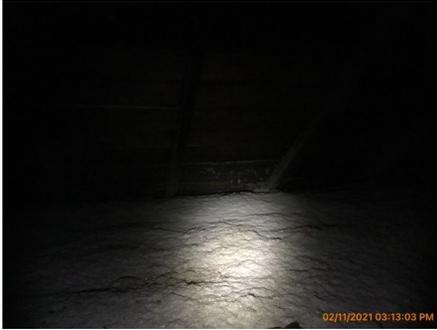
The attic has blown-in insulation.

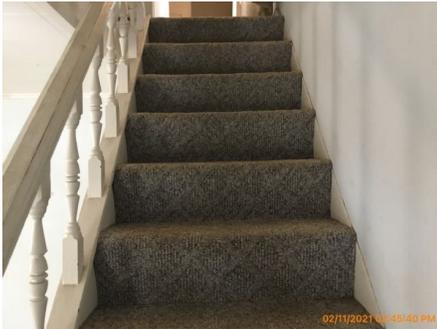
There is a slope in the stairs. We noted no resulting weakness, failure or nonperformance as a result of the slope. No immediate corrective actions are required.

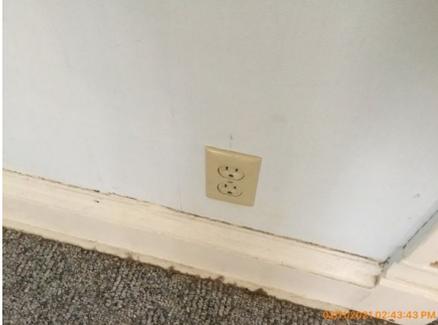
There are several ungrounded three prong receptacles in this area. We recommend they be properly grounded or restored to their original two prong configuration.

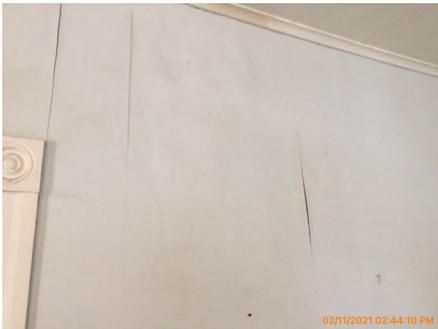
The wall surfaces are blemished, and can be repaired in the course of routine maintenance.

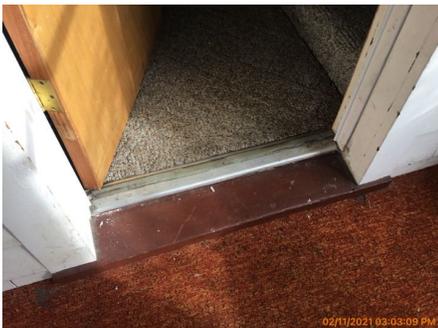
The door threshold is loose. We recommend adjustment for smoother operations.

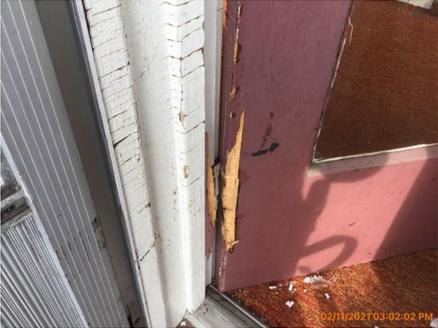
The door is damaged. We recommend it be repaired or replaced.

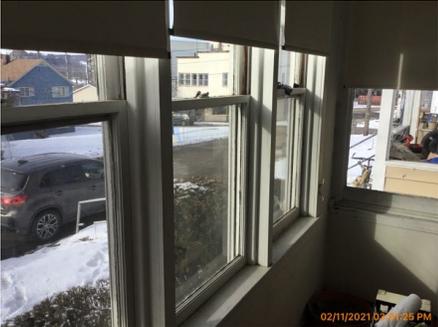
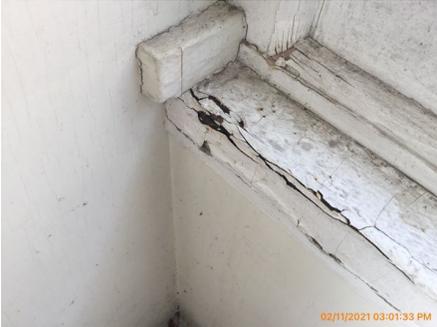
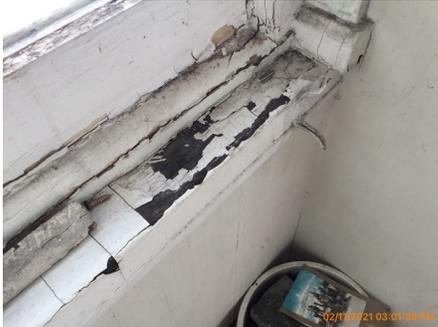
Several windows don't close tightly and are difficult to latch. All windows should be detailed, including scraping excess paint build-up, cleaning, lubricating, and adjusting hardware where necessary.

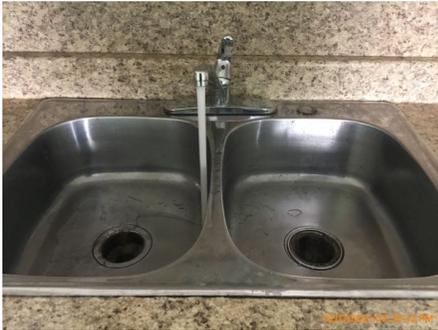
The sink appears to be properly installed. When operated, it was observed to be fully functional and in serviceable condition.

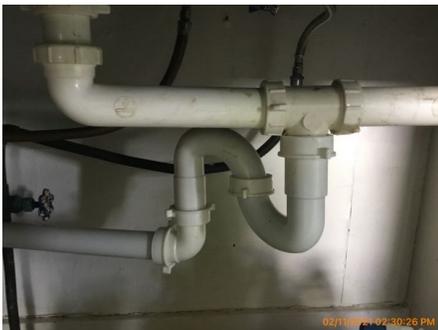
The drain trap and associated piping are PVC plastic.

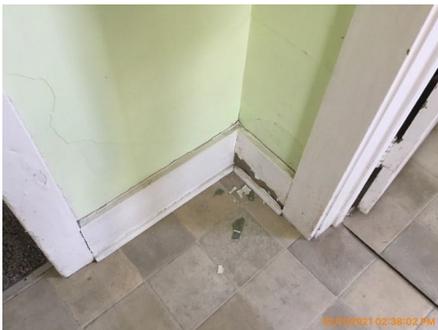
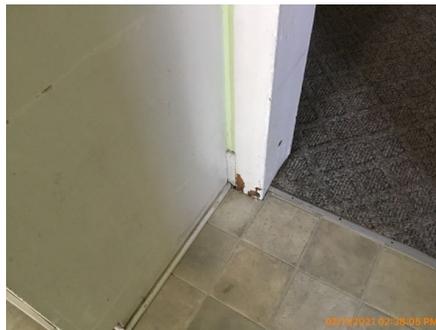
We recommend that the peeling paint on the trim be painted for better appearance.

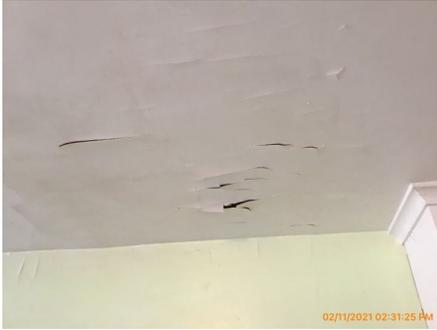
## **CEILING**

The ceiling surface is blemished, and can be repaired in the course of routine maintenance.

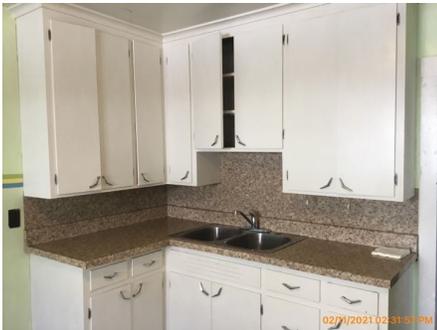
## **CABINETS**

The cabinets are in serviceable condition. Several of the doors need adjustment of hinges and latches for smoother operation.

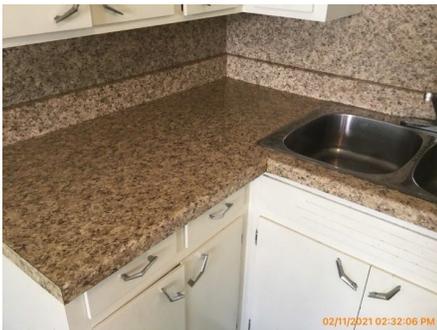
## **COUNTERTOPS**

The countertop is in serviceable condition.

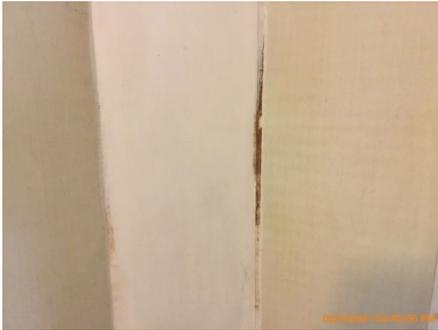
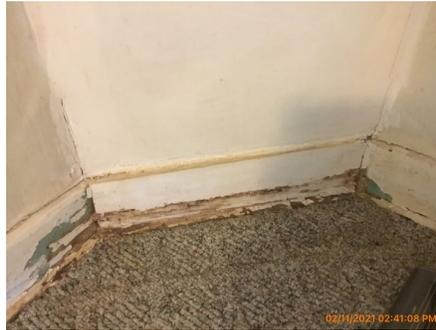
There is water staining, however no sign of active leakage was detected. If additional staining develops, the source of leakage should be identified and necessary repairs performed. Prepare and refinish the surface to restore its appearance.

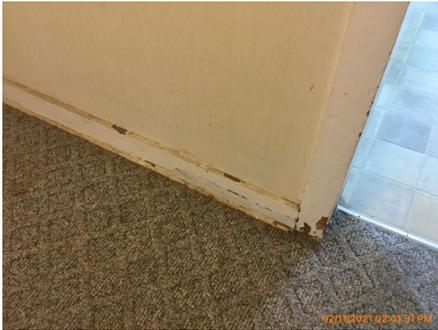
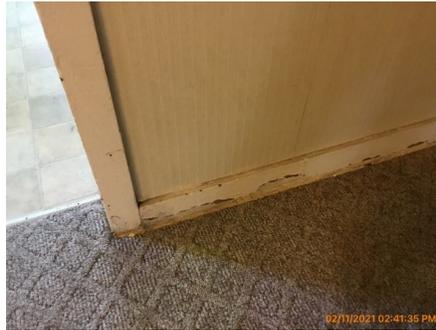
### TRIM

We recommend that the peeling paint on the trim be painted to prevent premature wear, moisture entry and deterioration.

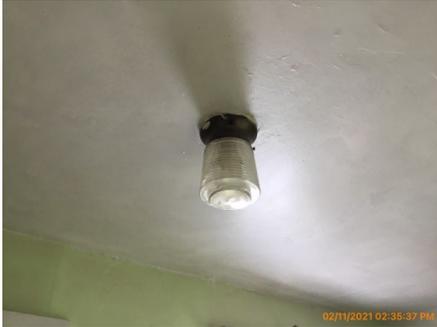
The light is not working. The bulb may have burned out. We recommend that the bulb be tested and replaced, if necessary, and the proper operation of the fixture be verified.

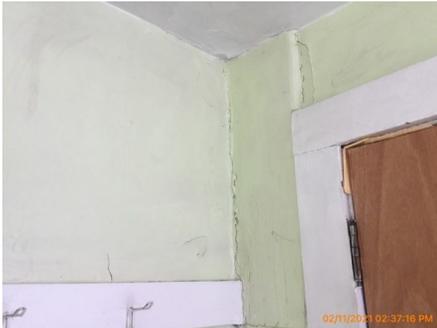
There are minor wall cracks. This type of cracking in this material is common and does not indicate a structural deficiency. These can be patched, prepared and finished in the course of routine maintenance.

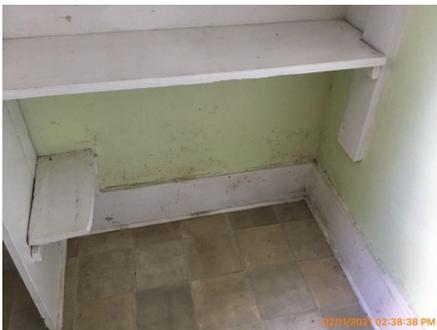
Mold and mildew have built up on the exposed wall surfaces. We recommend these surfaces be cleaned and chemically treated to remove the growth. After cleaning, sealing with a shellac based primer will help prevent 'bleeding' of old stains.

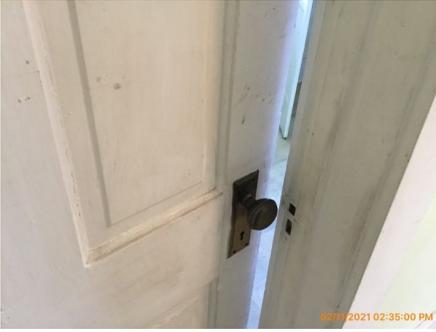
The door doesn't latch. We recommend minor adjustments to the hardware to restore proper function.

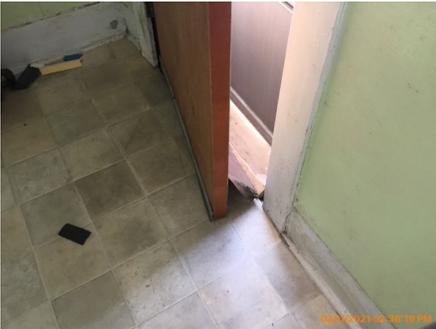
The door is damaged. We recommend it be repaired or replaced.

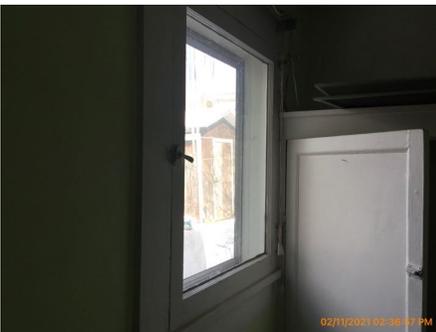
The window is stuck or has been painted shut and cannot be opened. We recommend repair to restore functional use.

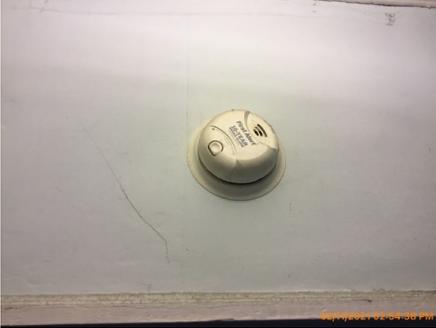
The smoke detector alarm was activated when the test button was depressed.

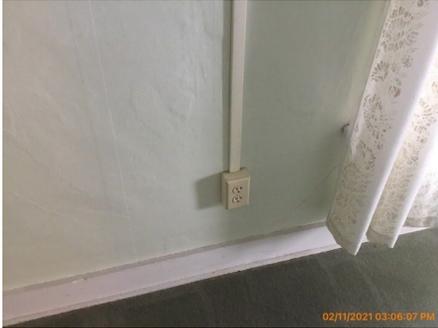
There is an ungrounded three prong receptacle. We recommend it be properly grounded.

There are a minimal number of available operating receptacles in this room. We recommend additional receptacles be installed to meet present and/or future needs and eliminate the use of extension cords.

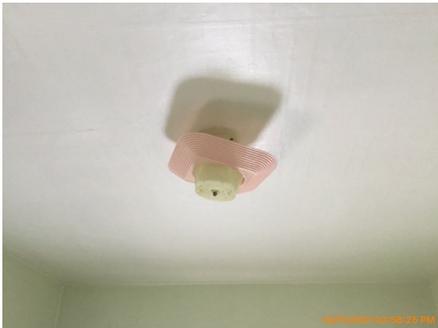
The light is not working. The bulb may have burned out. We recommend that the bulb be replaced, if necessary, and the proper operation of the fixture be verified.

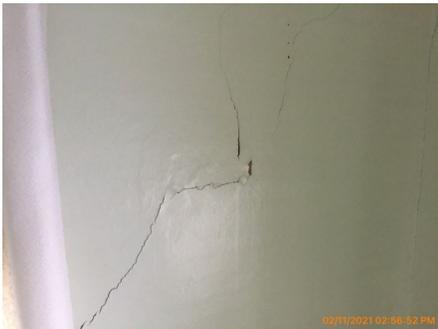
There are minor wall cracks. This type of cracking in this material is common and does not indicate a structural deficiency. These can be patched, prepared and finished in the course of routine maintenance.

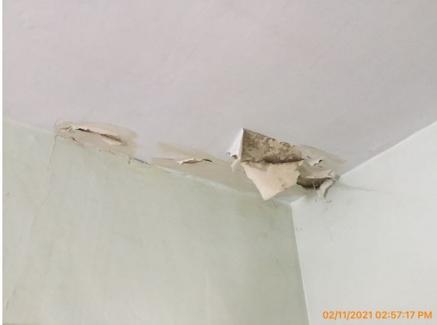
The ceiling is damaged. We recommend repair or refinishing.

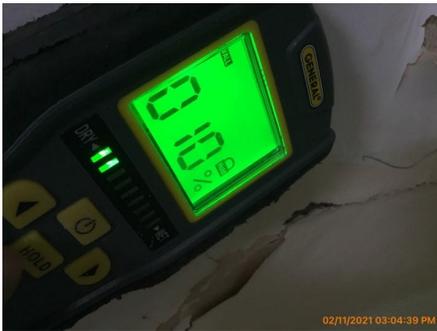
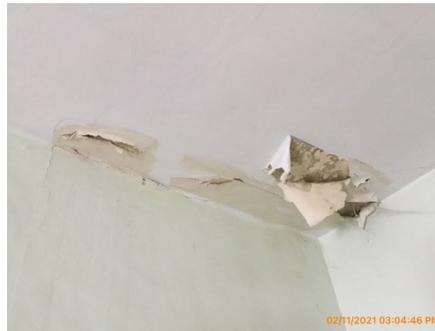
The ceiling is stained and was moist to the touch. This suggests an active leak. The source of leakage should be identified and necessary repairs performed. Stained surfaces should then be prepared and refinished to restore their appearance.

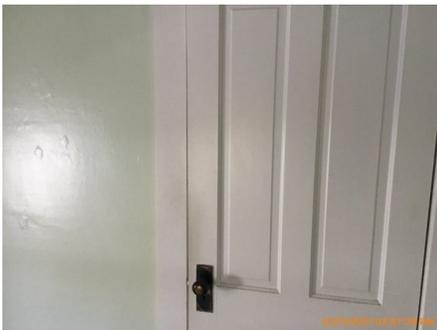
## CLOSET DOORS

The closet door rubs and does not close properly. We recommend adjustment for smoother operation.

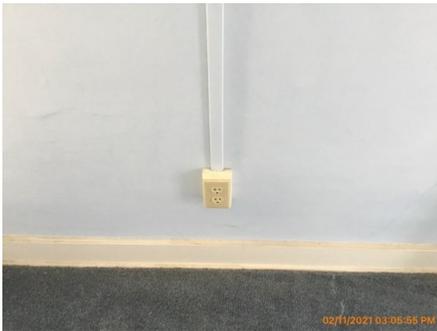
There is an ungrounded three prong receptacle. We recommend it be properly grounded.

There are a minimal number of available operating receptacles in this room. We recommend additional receptacles be installed to meet present and/or future needs and eliminate the use of extension cords.

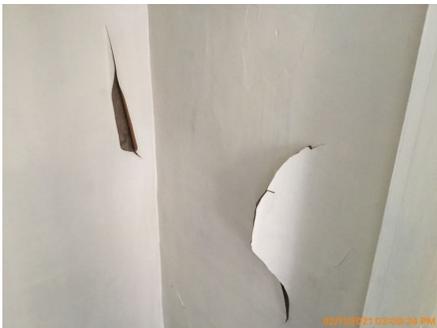
The wall surfaces are blemished. This can be repaired in the course of routine maintenance.

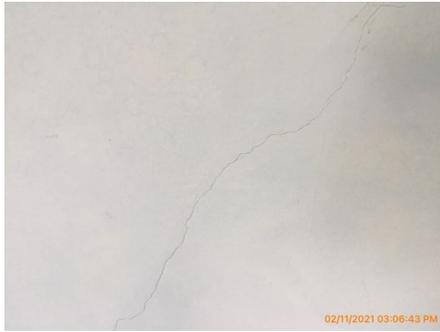
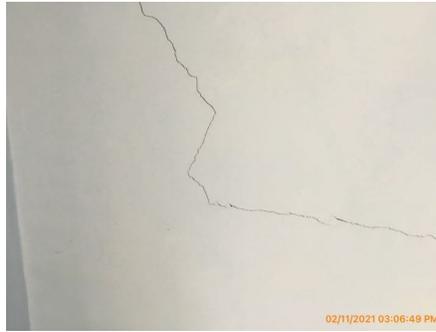
There are minor wall cracks. This type of cracking in this material is common and does not indicate a structural deficiency. These can be patched, prepared and finished in the course of routine maintenance.

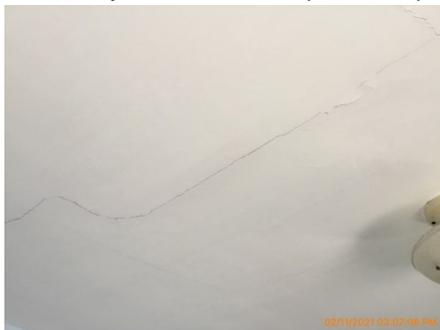
There are minor ceiling cracks. This type of cracking in this material is common and does not indicate a structural deficiency. These can be patched, prepared and finished in the course of routine maintenance.

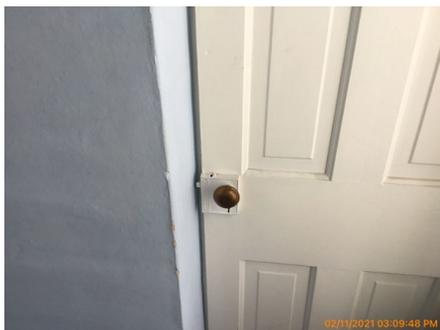
### **CLOSET DOORS**

The door doesn't latch. We recommend minor adjustments to the hardware to restore proper function.

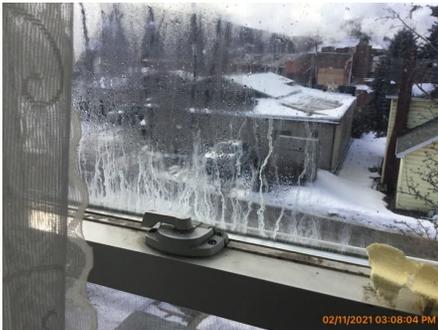
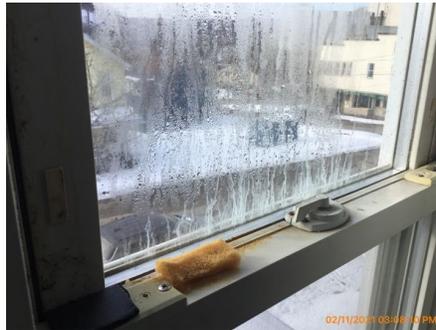
## WINDOWS

There is condensation between the panes of glass of several double pane windows. This indicates a failed seal. We recommend the lens assemblies be replaced, which is the only method for correcting this deficiency.

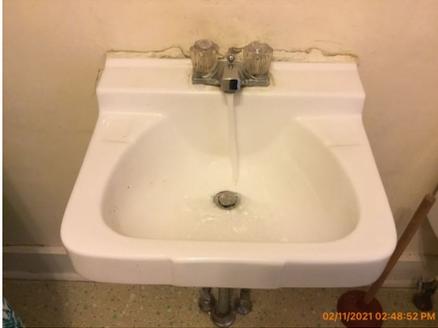
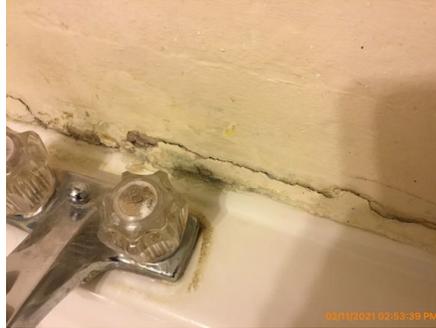
The wash basin appears to be properly installed. When operated, it was observed to be fully functional and in serviceable condition. Although the caulking is poor.

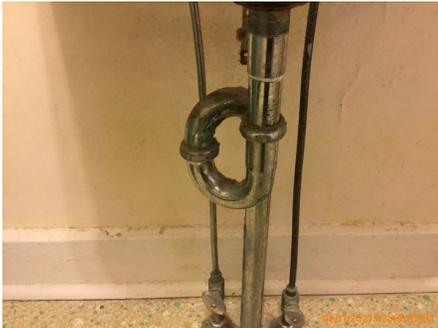
The drain trap and associated piping are chromed metal.

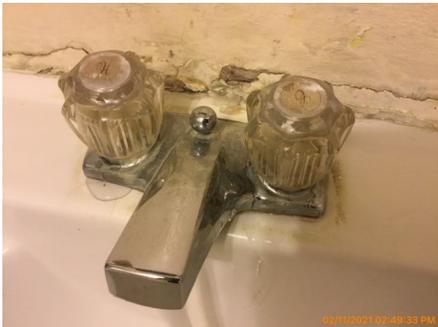
The sink faucet is leaking. We recommend that it be repaired or replaced.

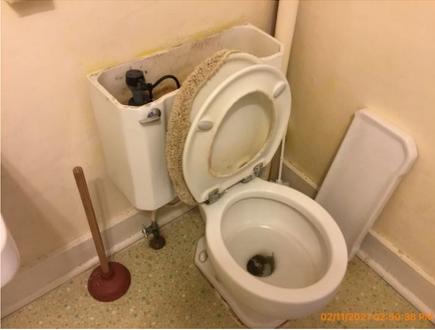
The toilet was not operational. We recommend the toilet be repaired or replaced.

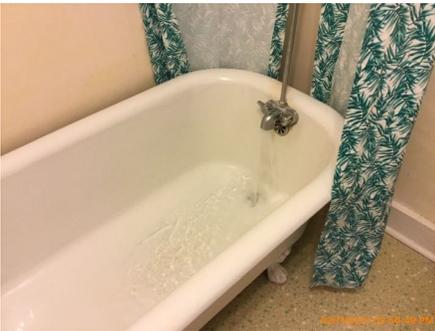
The bathtub appears to be properly installed and in serviceable condition.

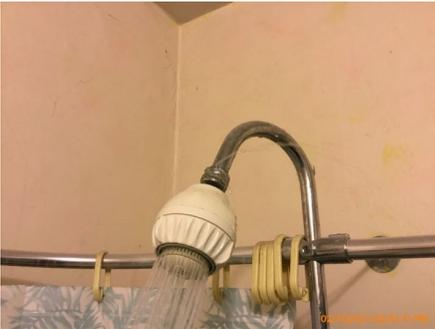
The shower was operated for the inspection and a leak was observed. We recommend repair.

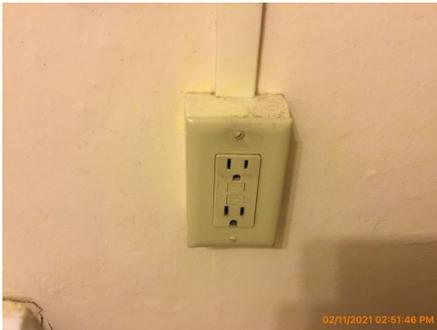
The GFCI protection for this bathroom did not function properly when tested. We recommend the source of the problem be identified and corrected.

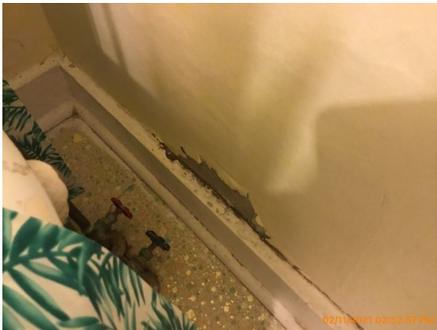
### INTERIOR WALLS

The wall surfaces are blemished. This can be repaired in the course of routine maintenance.

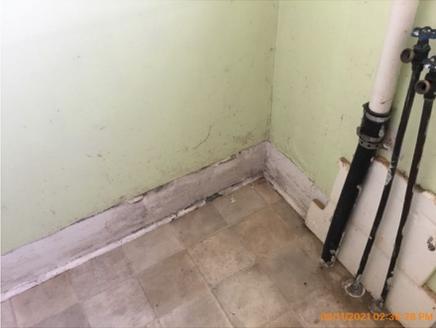
Mold and mildew have built up on the exposed wall surfaces. We recommend these surfaces be cleaned and chemically treated to remove the growth. After cleaning, sealing with a shellac based primer will help prevent 'bleeding' of old stains.

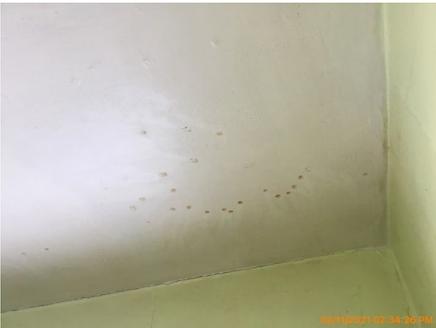
Mold and mildew have built up on the ceiling. We recommend these surfaces be thoroughly cleaned and chemically treated to remove this growth. Sealing with a shellac based primer will help prevent bleeding of old stains.

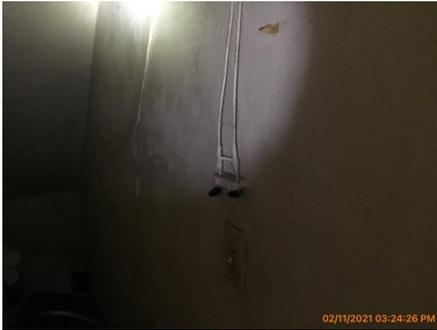
We found exposed wiring at the stairway. Even if insulated, we recommend all wiring be encased in a conduit or otherwise protected in accordance with present standards.

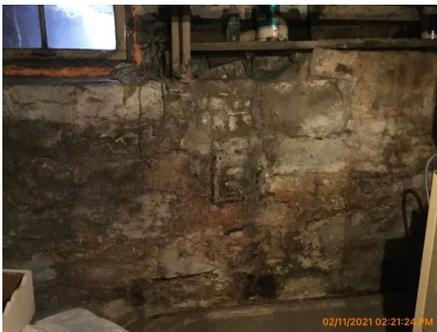
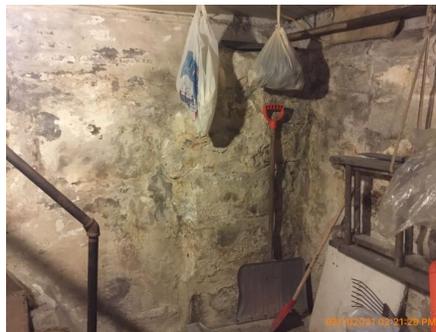
### WALLS

The basement walls have performed well and are in good condition for the age of the structure.

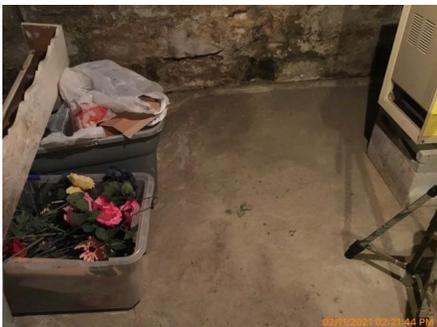
The basement floor is a concrete slab. Minor cracks are visible. These cracks are considered cosmetic in nature and are not structurally significant. No action is indicated.

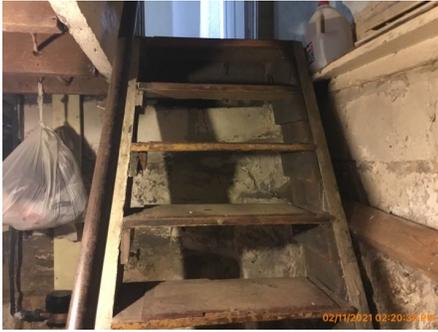
The stairs were used several times during the inspection. The various components appear to be properly installed and no deficiencies were noted during use.

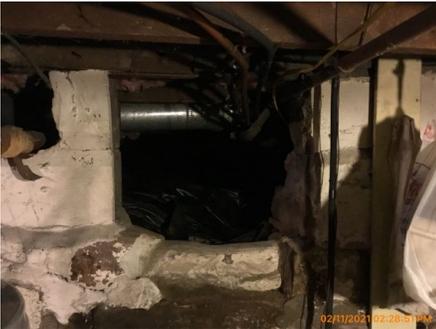
The crawl space is accessible from the basement.

Access to the crawl space was restricted, The crawlspace could be only partially inspected from the opening.

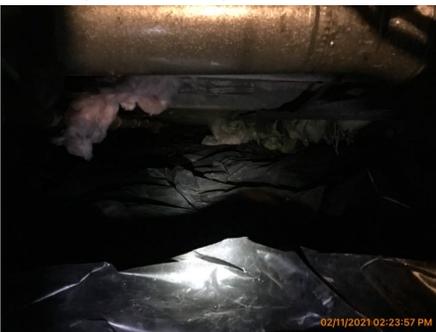
The soil has been covered with plastic sheeting, probably installed in an attempt to reduce moisture levels in the crawl space atmosphere. This is considered a beneficial feature and is required in some jurisdictions.

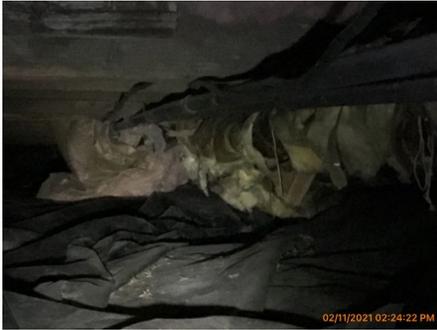
There are fiberglass batts in the area that have fallen out of place. We recommend this material be secured back in place.

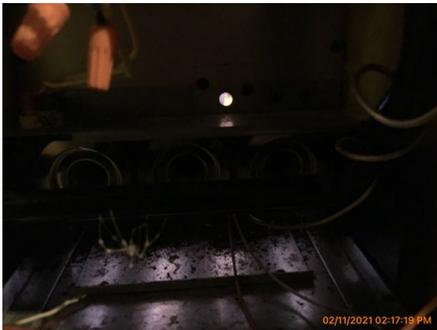
The boiler appears to be properly installed and in serviceable condition.

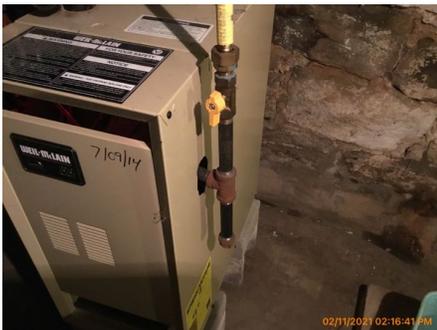
#### **GAS SUPPLY**

The gas piping includes a 90 degree shutoff valve for emergency use. The valve was not tested at the time of inspection. This age and style of valve is normally found to be operable by hand and generally trouble free.

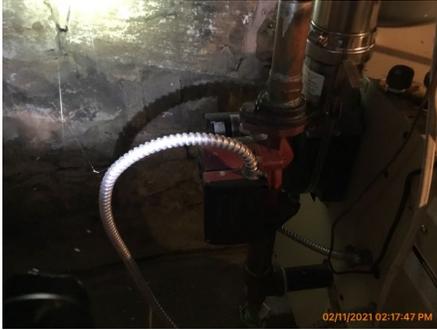
### **CIRCULATING PUMP**

The circulating pump for the heating system appears to be properly installed and in serviceable condition.

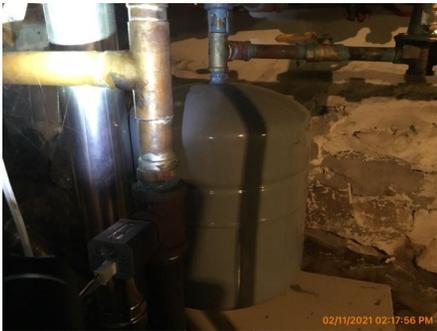
### **EXPANSION TANK**

The expansion tank appears to be properly installed and in serviceable condition.

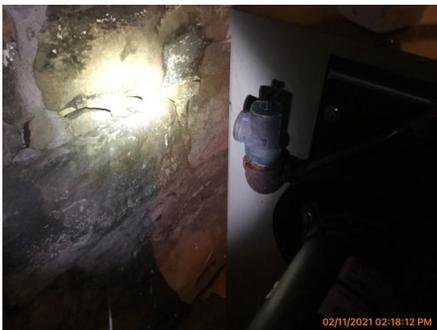
The temperature and pressure relief valve lacks a discharge pipe. We recommend the installation of approved piping to an approved location.

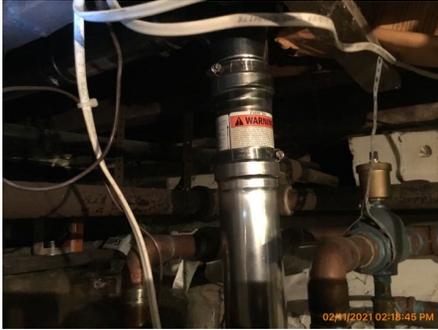
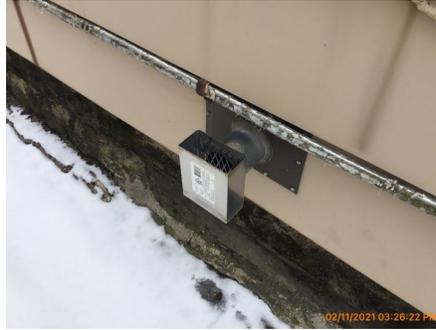
## VENT

The heating system vent is properly installed and appears to be in serviceable condition where seen.

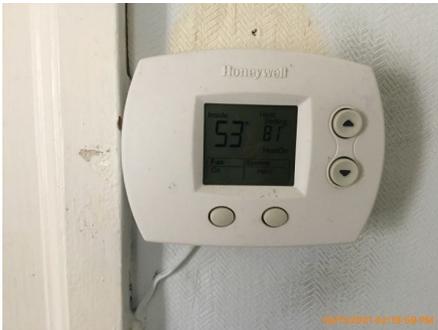
The thermostat appears to be properly installed and the unit responded to the user controls.

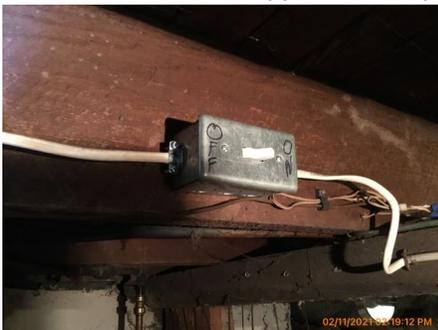
The local disconnect appears to be properly installed and in good condition.

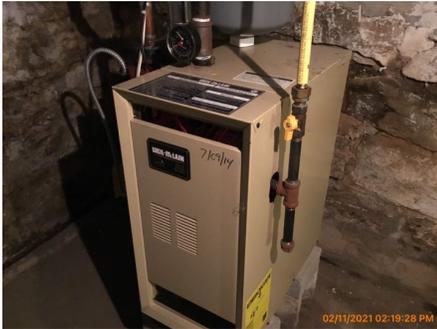
The heating system responded to normal operating controls. Components appear to be properly installed and serviceable. Our inspection is a visual non evasive inspection checking operations of the unit by use of standard operate controls. We recommend a full evaluation and service of the unit be conducted by a HVAC contractor prior to closing.

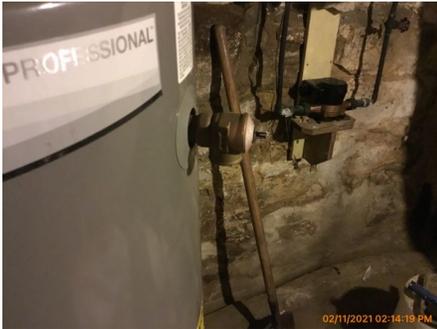
The water heater is equipped with a temperature and pressure relief valve. This device is an important safety device and should not be altered or tampered with. We observed no adverse conditions.

The temperature and pressure relief valve lacks a discharge pipe. We recommend the installation of approved piping to an approved location.

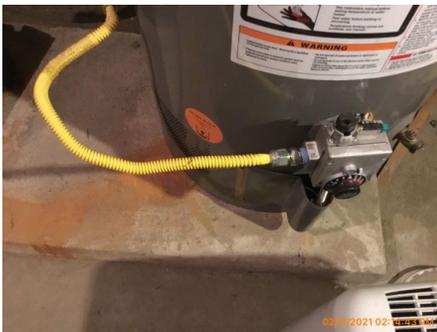
The fuel piping does not include a 'T' extension to collect condensation and debris, as is considered good practice. In the course of future upgrading or repair, a 'drip leg' should be added to the gas piping just ahead of the connector.

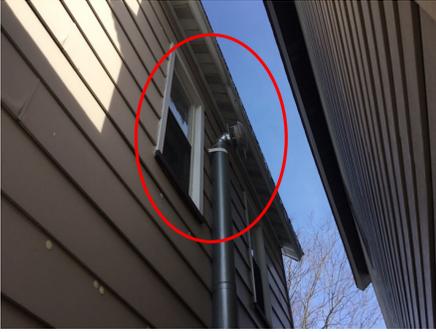
## VENTING

The water heater vent has been installed in a substandard manner. We recommend it be repaired or replaced.

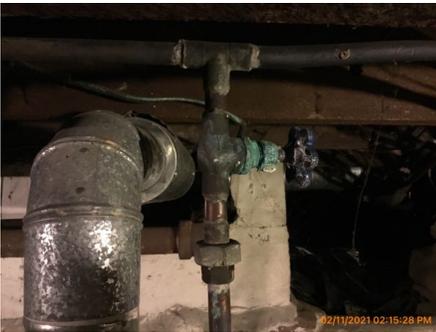
## WATER CONNECTORS

The water connections are corroded and leakage may become apparent over time. These connections should be monitored for leakage and repaired or replaced if necessary.

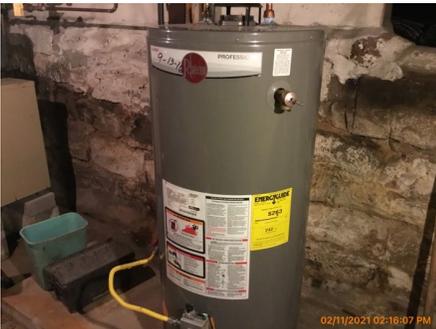
The hot water system responded to normal operating controls at time of inspection. We can not guarantee its remaining useful life as conditions and use vary.

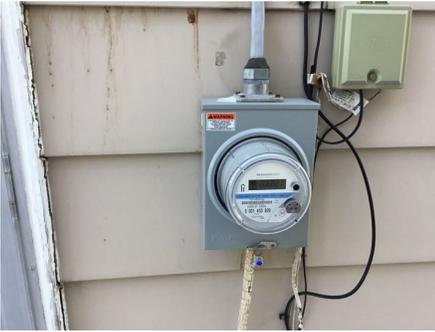
The electric meter is outside on the left side of the building.

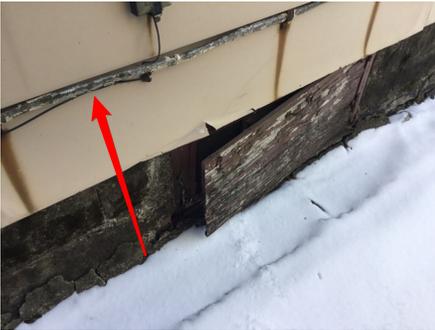
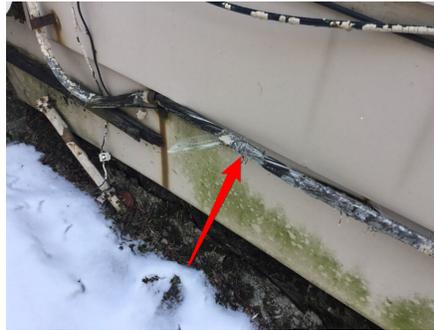
### SERVICE DROP

The service cable is old and the insulation is frayed. We recommend the utility provider be notified of this condition so they can upgrade or replace the wires.

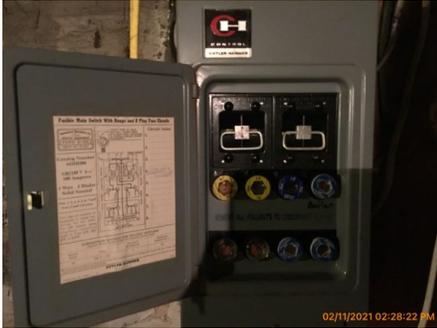
### **FSE MAIN PANEL**

The main service panel is in serviceable condition with circuitry installed and fused correctly. The service panel does not meet present standards but upgrades are optional and would usually only be considered along with other improvements.

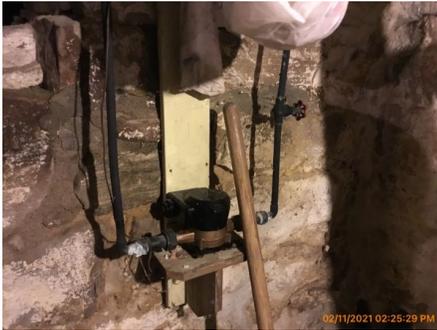
The domestic water supply main shut-off valve is in the basement.
